Manhole Inspection Summary

Manhole # S43KK_051MH

Insp Date: **8/12/08 12:37 PM**

Location Address: **RUTLAND**

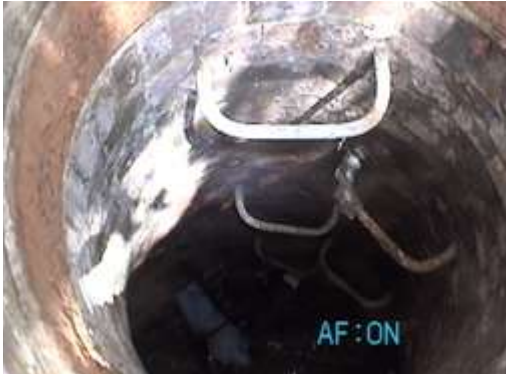
Defect 2

☒ **Leaks**

Frame leaks

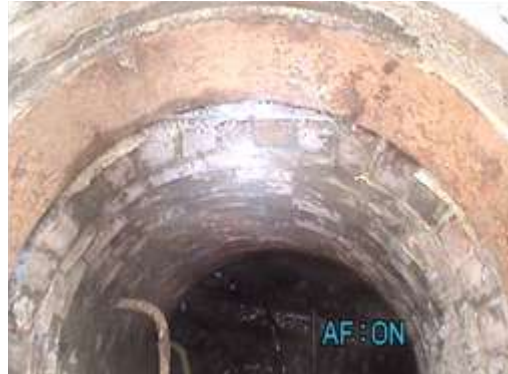
Defect 1

Infiltration: ☐ None ☐ Joint ☐ Cracks ☐ Mortar ☐ Roots ☒ **Wall**

Infiltration

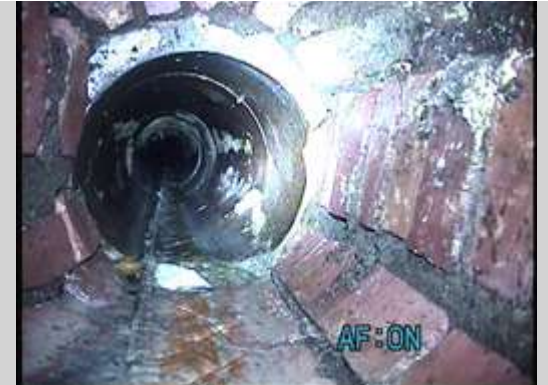
12 O'Clock Outflow

8 in. Circular Gravity Sewer
Pipe Out @ 12 O'Clock

Pipe Height: **8.4** (in.) Rod and Bar (Angled)
Pipe Material: **Clay** ☐ Pipe Lined
Invert Depth: **11.00** (ft.) Flow Characteristics: **Fast**
Deposits: ☐ None ☐ Mud ☐ Sludge ☐ Debris ☒ Grease
Silt Depth: **0.15** (in.) Deposits Extent: **Light**
Infiltration: **None** Pipe Seal Cond: **Sound**

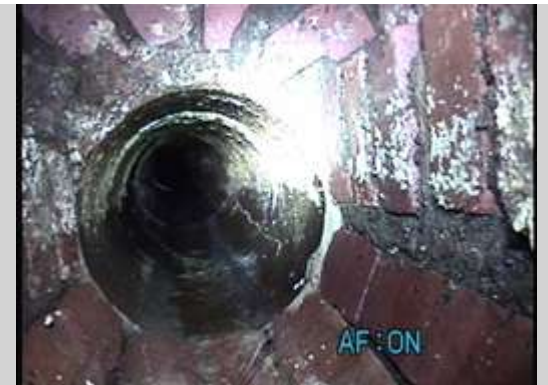
6 O'Clock Inflow

8 in. Circular Gravity Sewer
Pipe In @ 6 O'Clock

Pipe Height: **8.4** (in.) Rod and Bar (Angled)
Pipe Material: **Clay** ☐ Pipe Lined
Invert Depth: **10.90** (ft.) Flow Characteristics: **Fast**
Deposits: ☒ None ☐ Mud ☐ Sludge ☐ Debris ☐ Grease
Silt Depth: (in.) Deposits Extent:
Infiltration: **None** Pipe Seal Cond: **Sound**

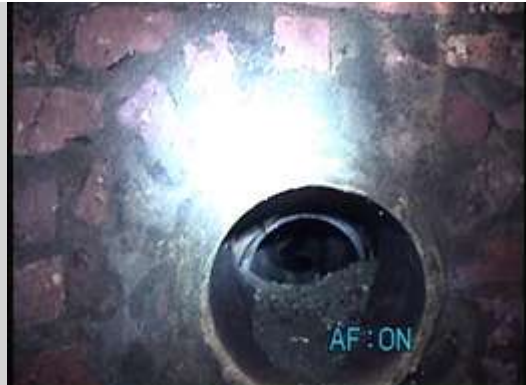
9 O'Clock Inflow

Pipe In @ 9 O'Clock

Pipe Height: **8.4** (in.) Rod and Bar (Angled)

Invert Depth: **7.20** (ft.) Flow Characteristics: **Slow**

Infiltration: **None** Pipe Seal Cond: **Sound**

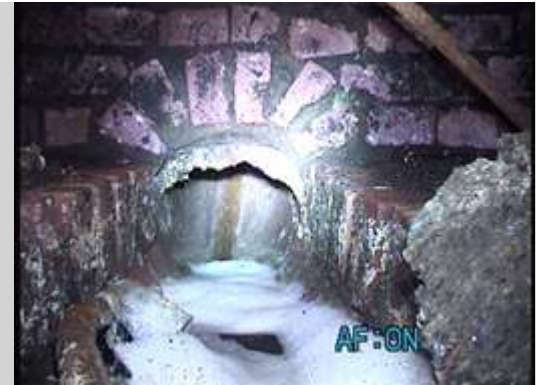
Drop In @ 9 O'Clock

Drop: **Inside**

Reading: **9.80** (ft.)

Inv Depth: **10.80** (ft.)

Drop Condition: **Open**
